# **CASTING BASIN GATE MAINTENTANCE RECORDS**

CYCLE 6

# Kiewit-General Inspection Report

**PROJECT:** SR 520 PONTOONS

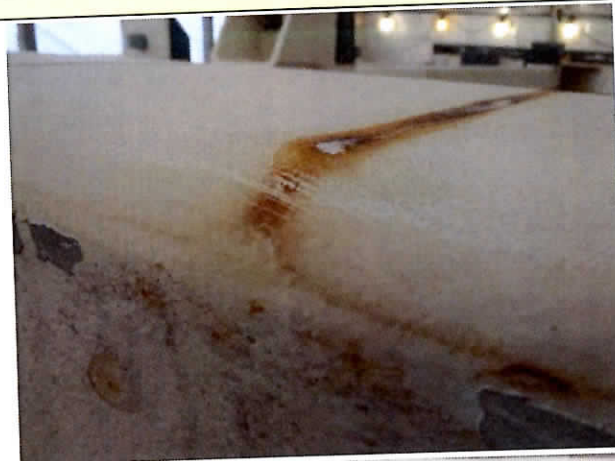
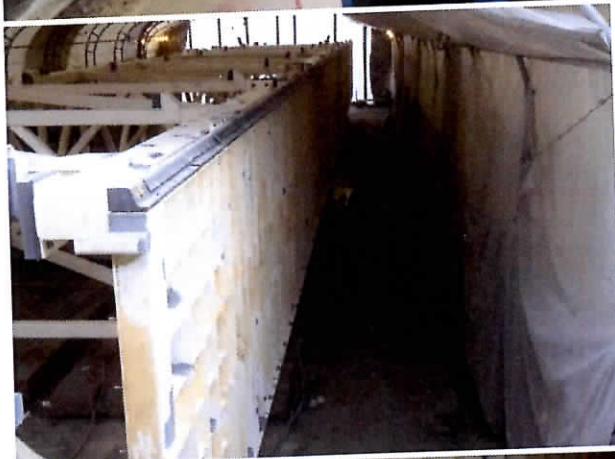
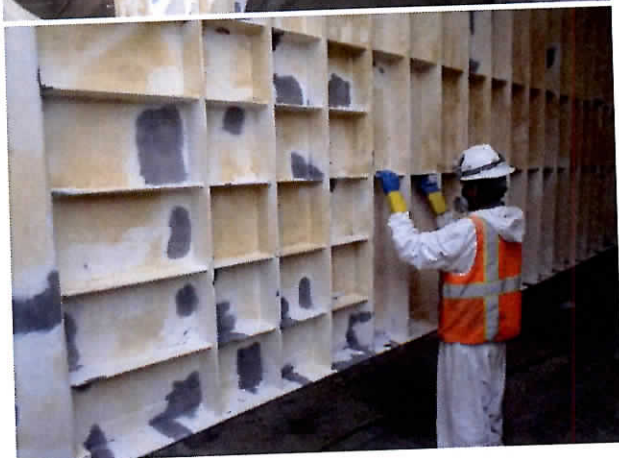
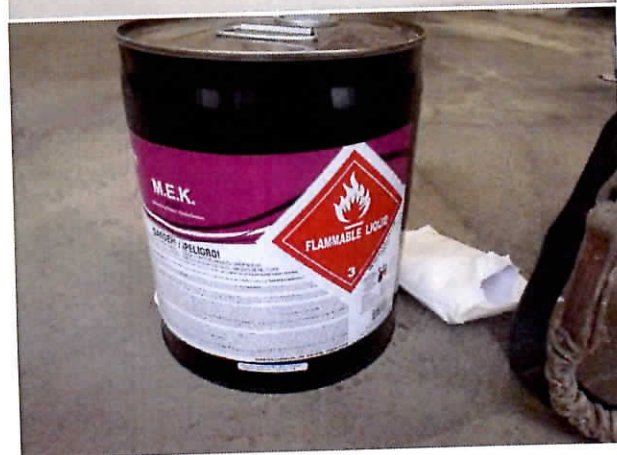
IDR Sheet	QA Key Personnel Function	Date
Sheet 8 of 13	Structural Inspector	Friday, March 13, 2015
Inspector Doug Brinius	IDR Report # 3/13/2015 DB	
Inspector's Notes Continued

TOP SIX: blasted surfaces, solvent, anchor profile of Trusses 2 and 3

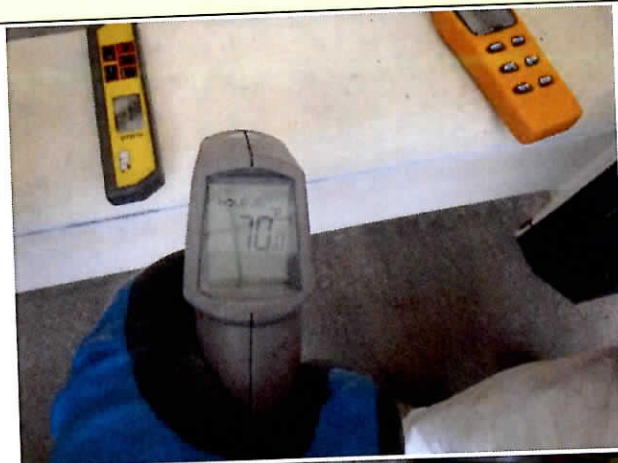
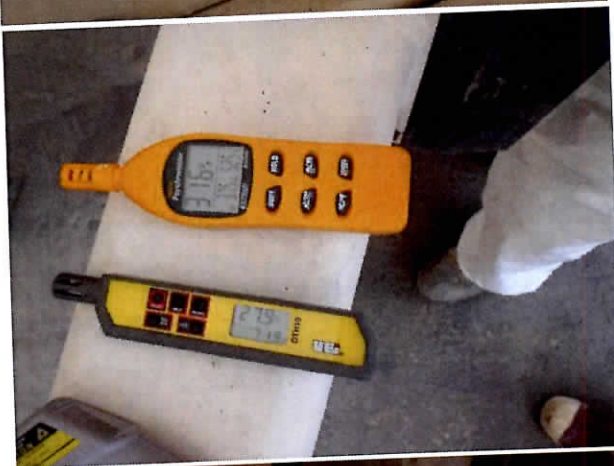
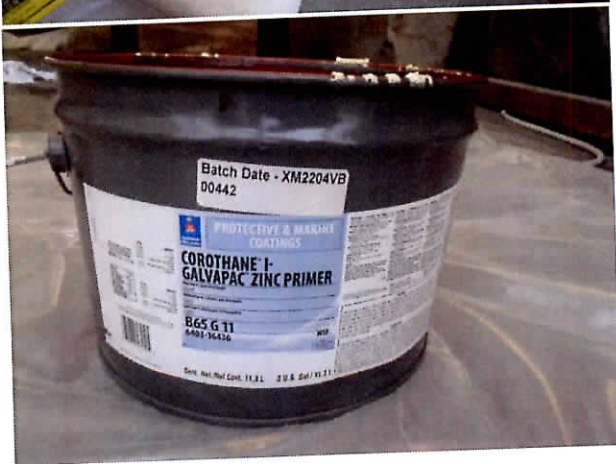
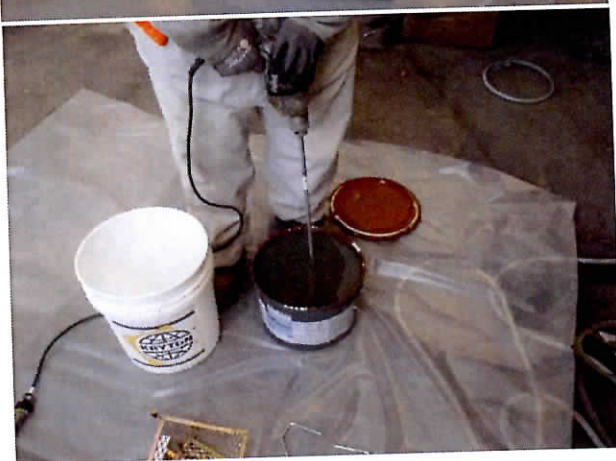
IDR Sheet	QA Key Personnel Function	Date
Sheet 9 of 13	Structural Inspector	Friday, March 13, 2015
Inspector	IDR Report #	
Doug Brinius	3/13/2015 DB	
Inspector's Notes Continued

TOP SIX: Zinc primer mixing, atmospheric testing Trusses 2 and 3

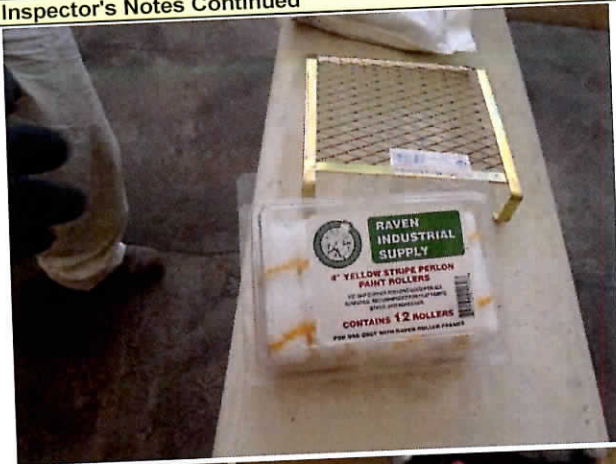
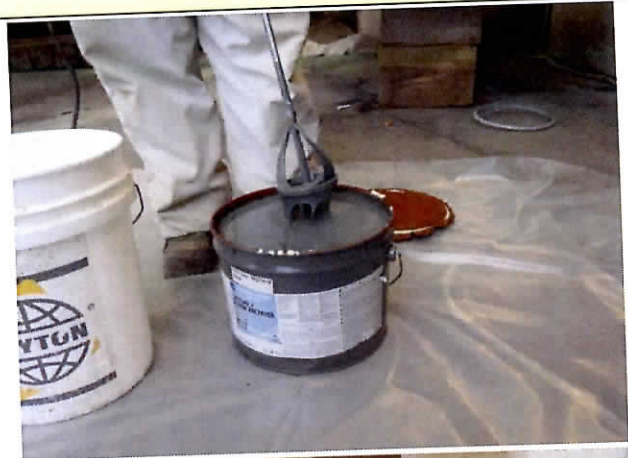
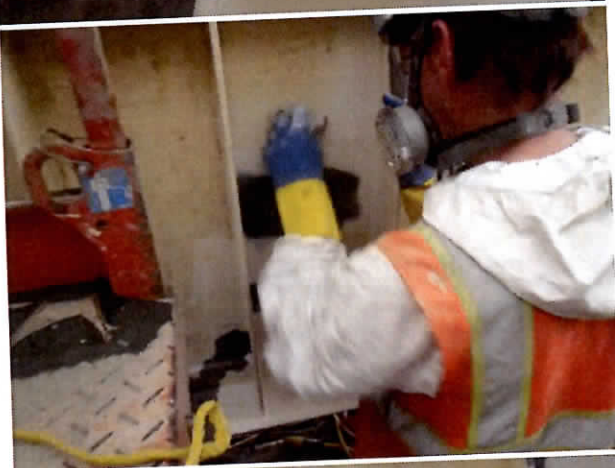
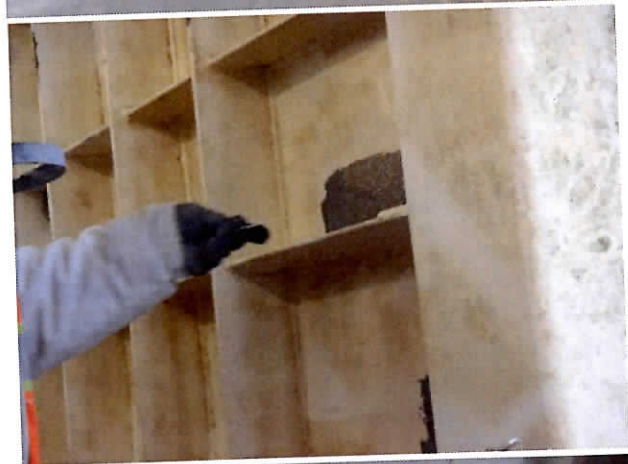
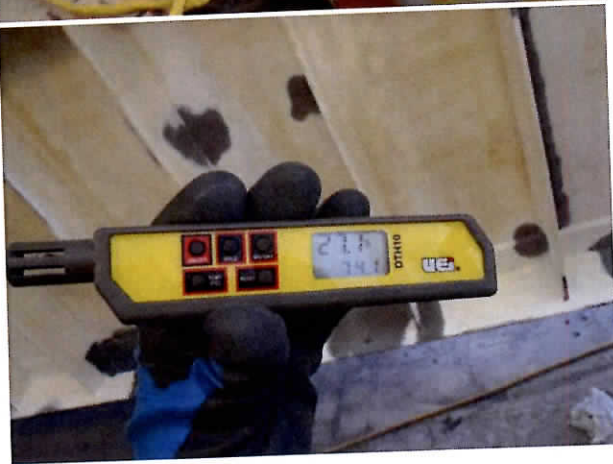
IDR Sheet Sheet 10 of 13	QA Key Personnel Function Structural Inspector	Date Friday, March 13, 2015
Inspector Doug Brinius		IDR Report # 3/13/2015 DB
Inspector's Notes Continued

TOP SIX: Zinc priming, WFT testing, atmospheric testing Trusses 2 and 3

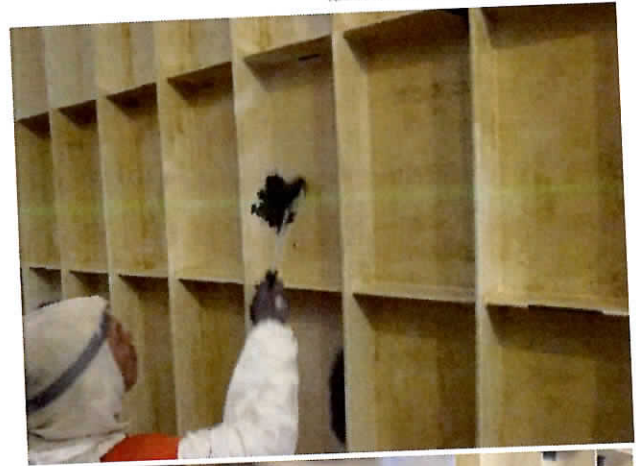
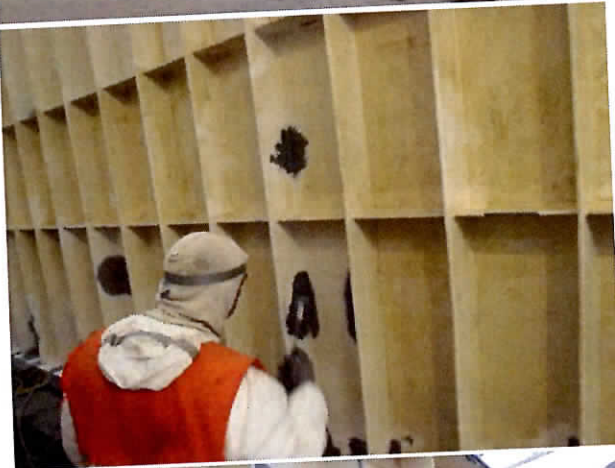
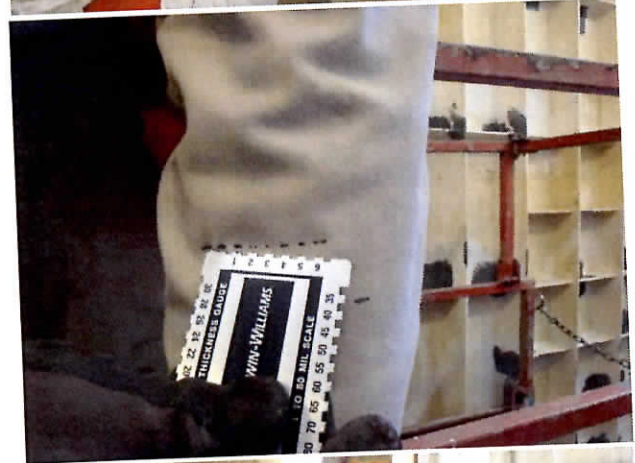
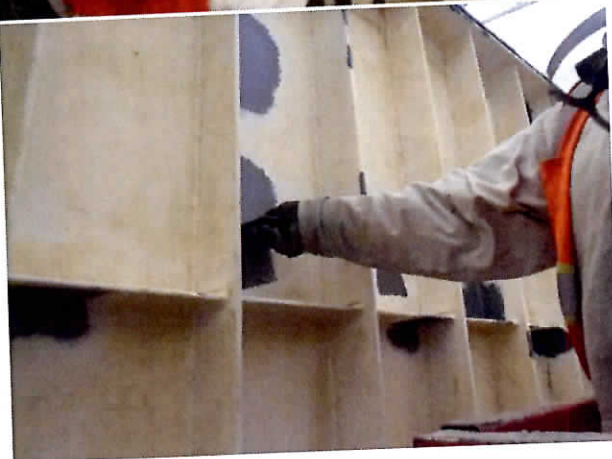
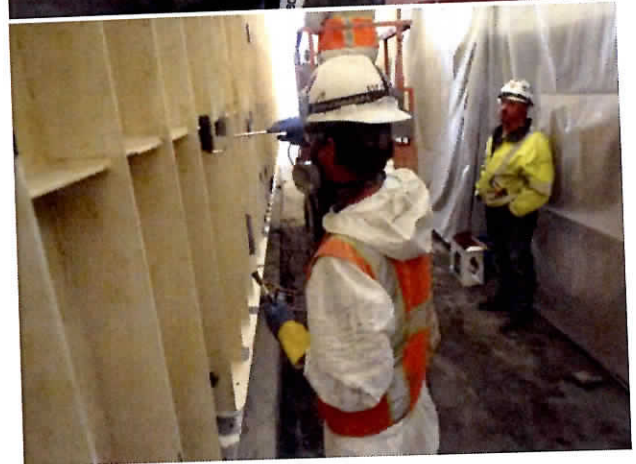
TOP SIX: Zinc priming, WFT testing, Trusses 2 and 3

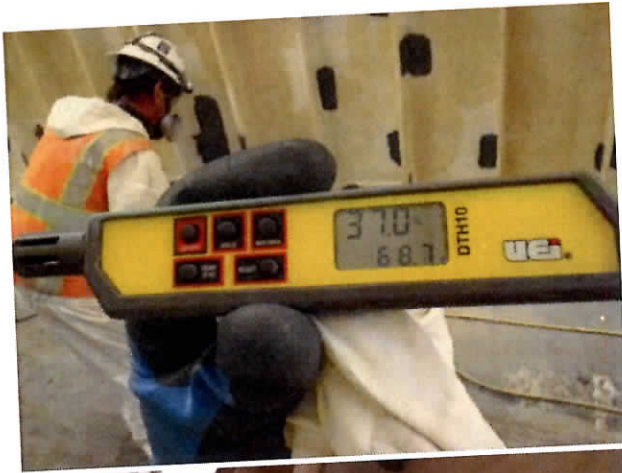
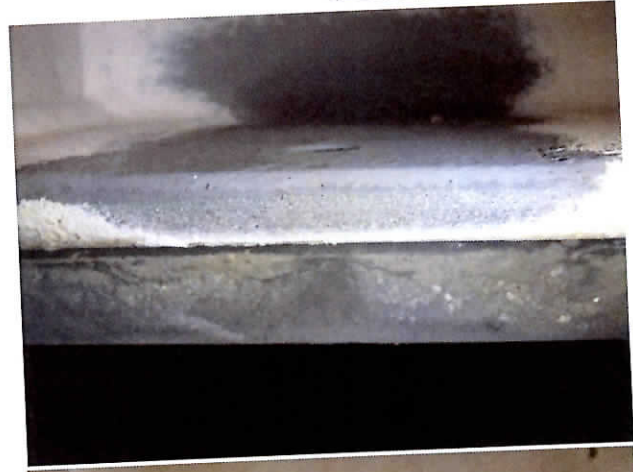
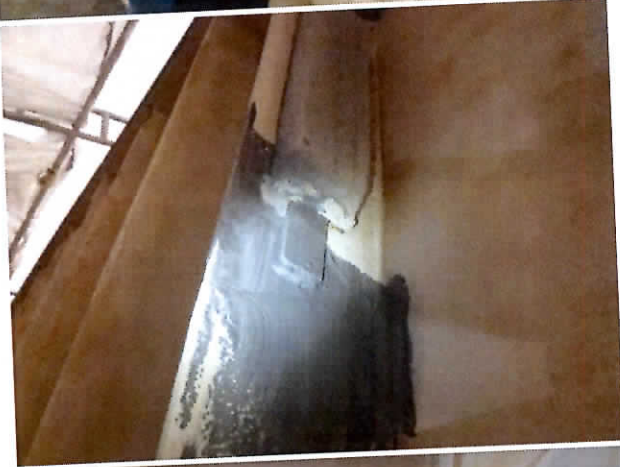
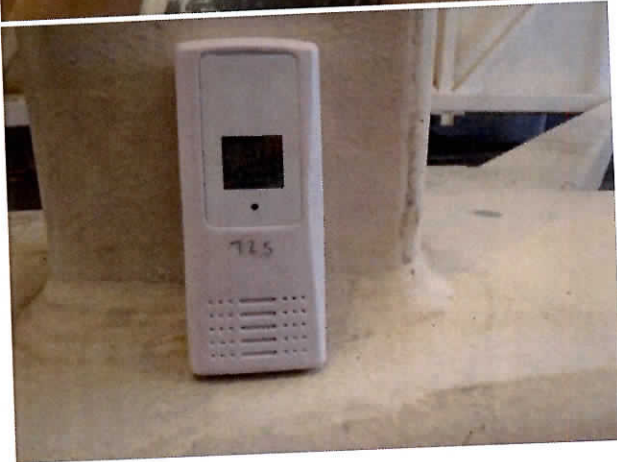
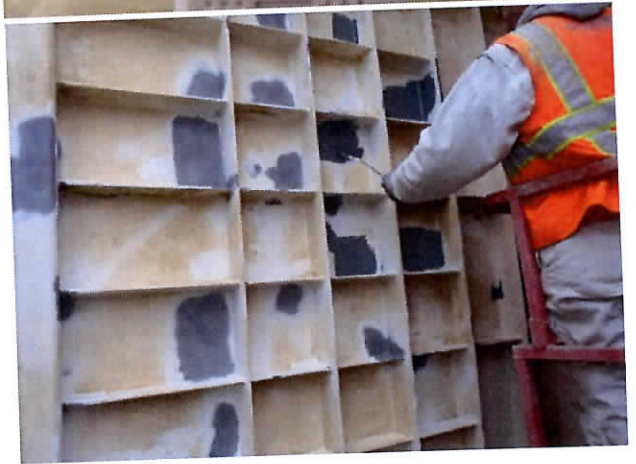
TOP SIX: Zinc priming and atmospheric conditions, Trusses 2 and 3

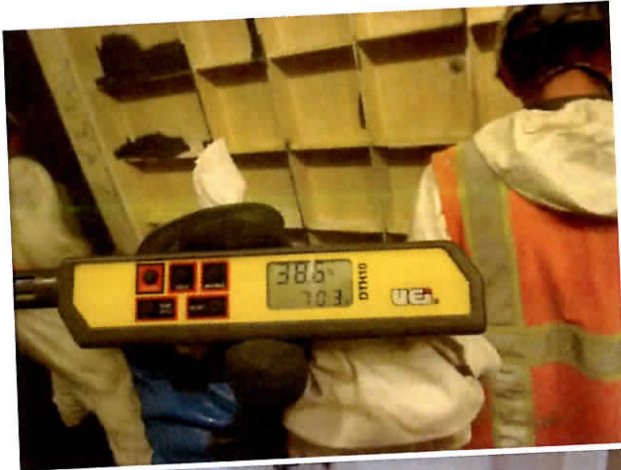
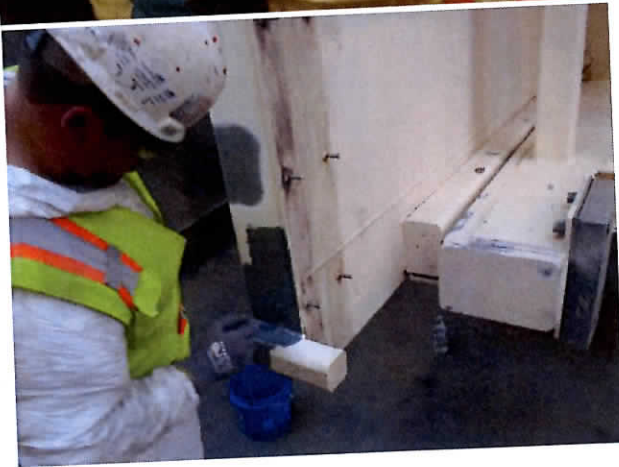
TOP FOUR: Zinc priming, Trusses 2 and 3

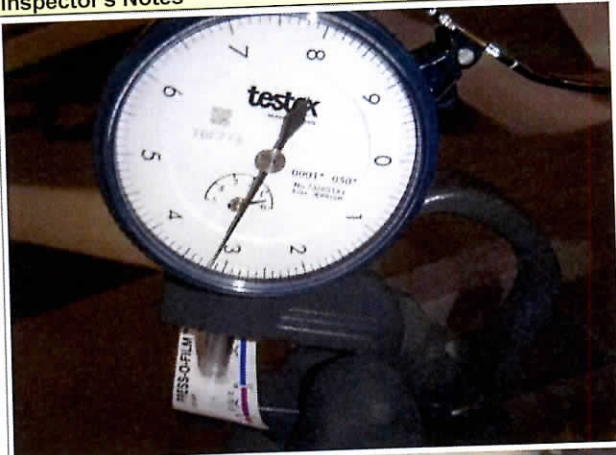
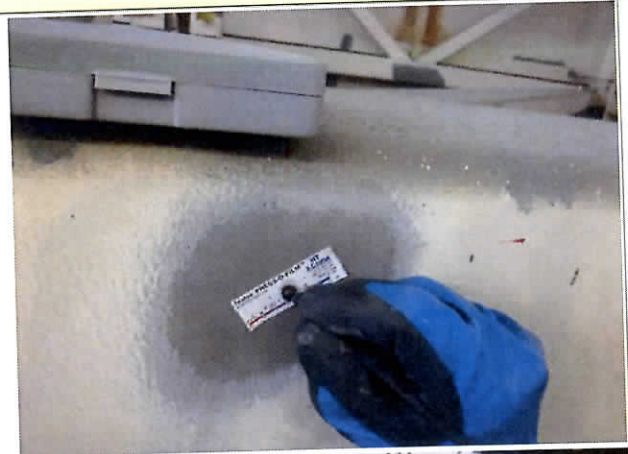
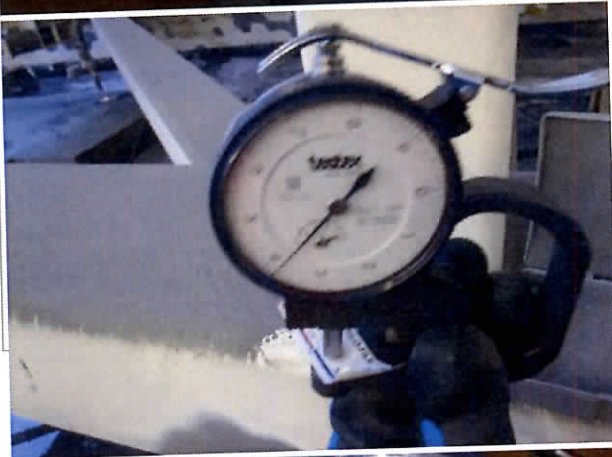
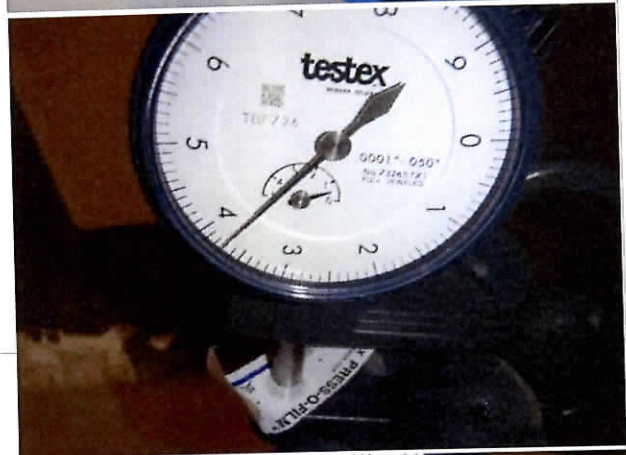
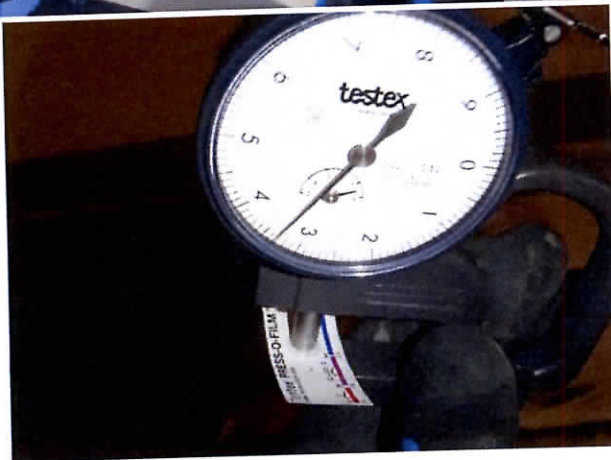
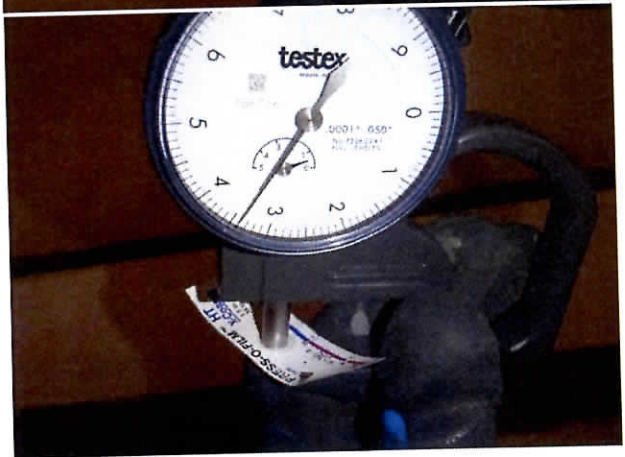
IDR Sheet Sheet 3 of 8	QA Key Personnel Function Structural Inspector	Date Sunday, March 15, 2015
Inspector Doug Brinius		IDR Report # 3/15/2015 DB
Inspector's Notes

TOP SIX: anchor profile of T1 repairs

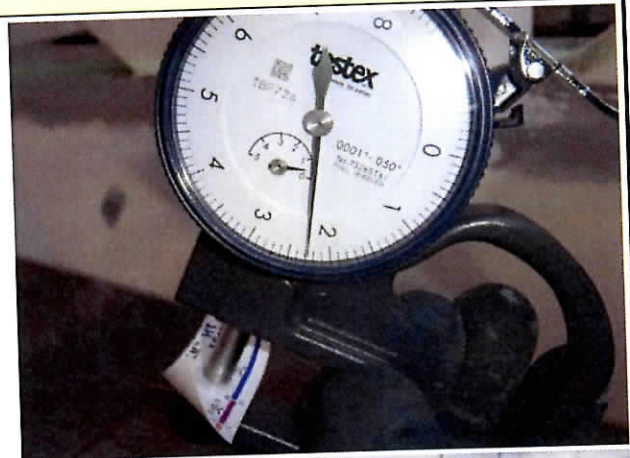
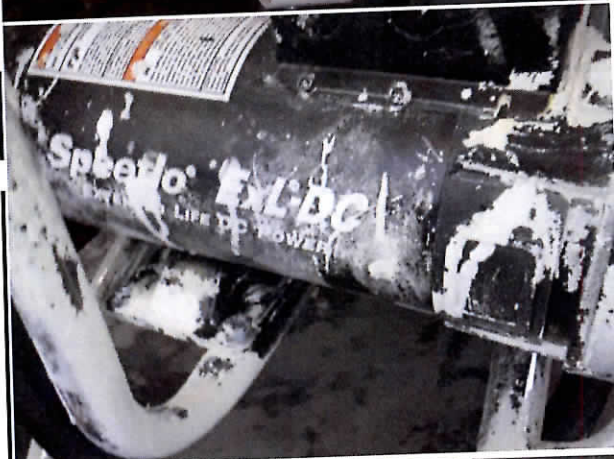
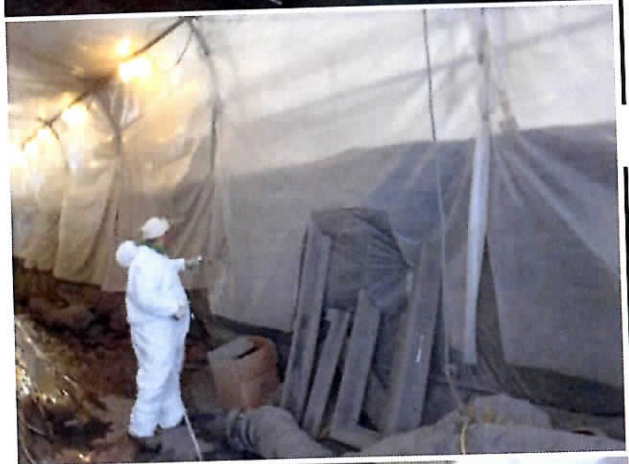
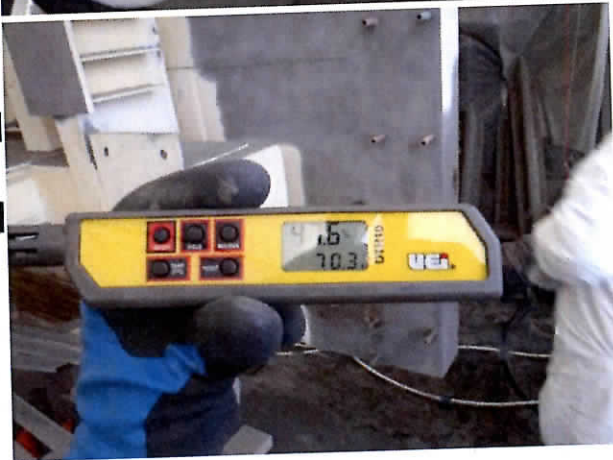
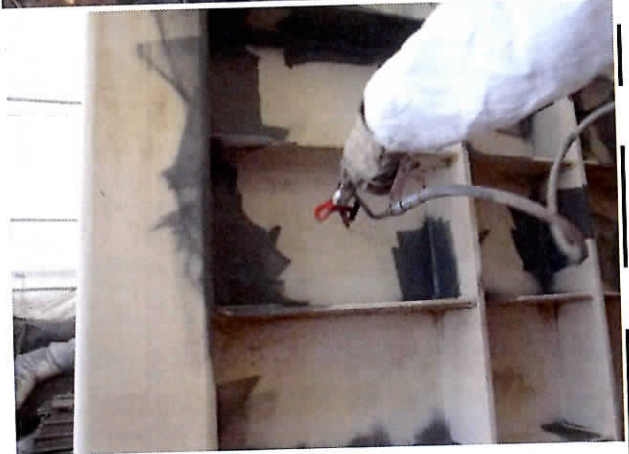
IDR Sheet	QA Key Personnel Function	Date
Sheet 4 of 8	Structural Inspector	Sunday, March 15, 2015
Inspector Doug Brinius	IDR Report # 3/15/2015 DB	
Inspector's Notes

TOP SIX: wet film thickness testing, priming repairs of T1, atmospheric conditions, anchor profile of T1 repairs

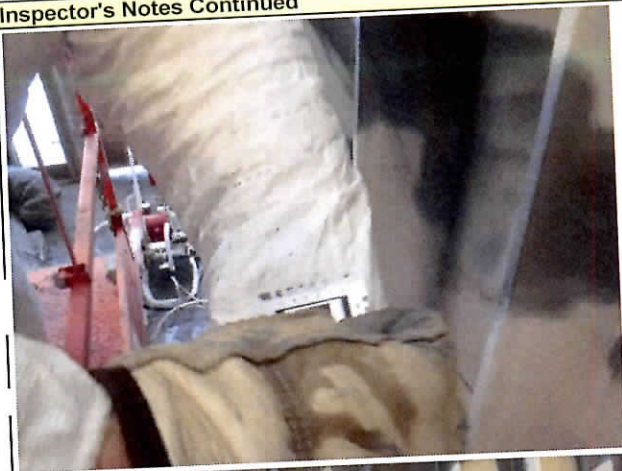
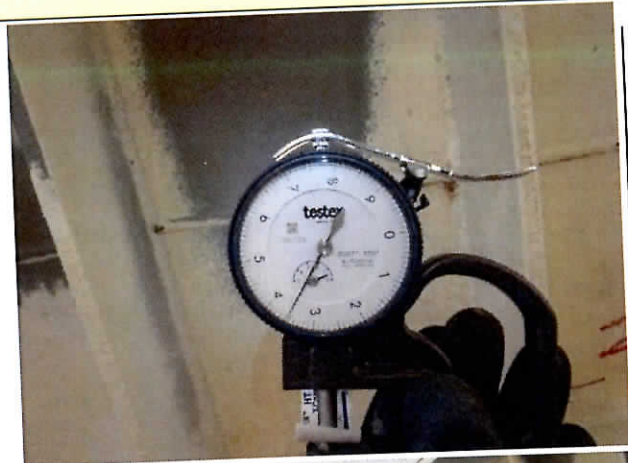
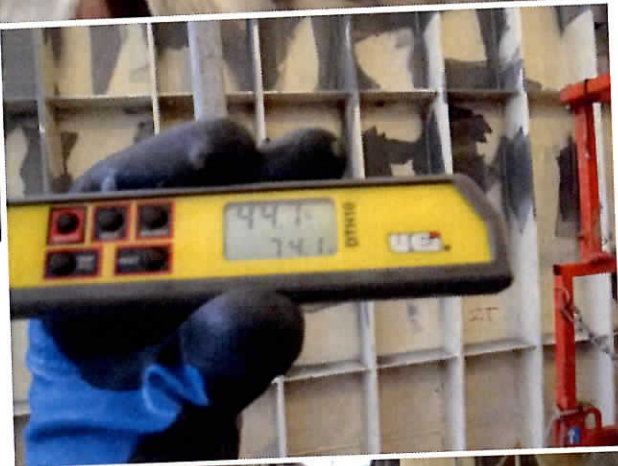
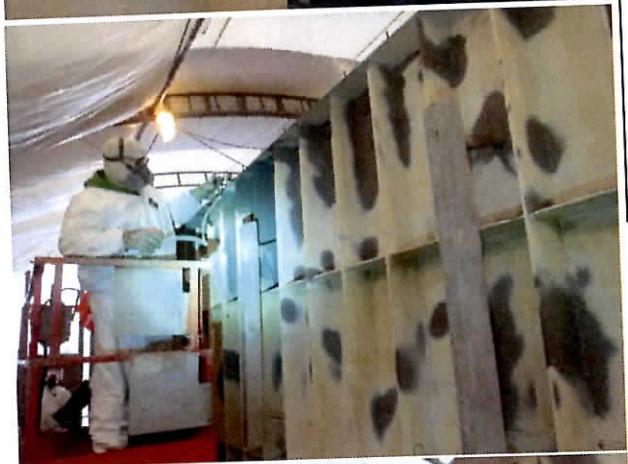
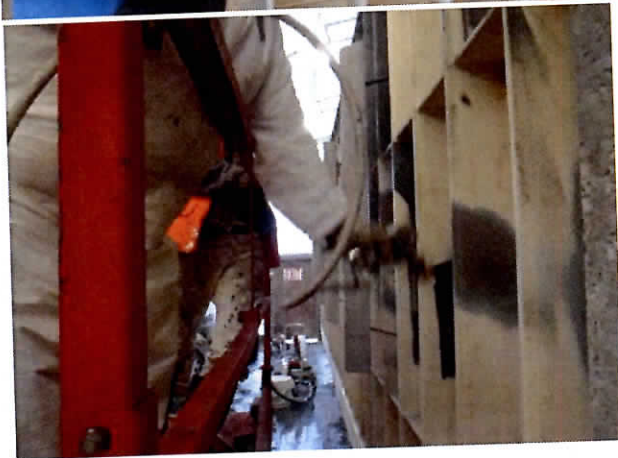
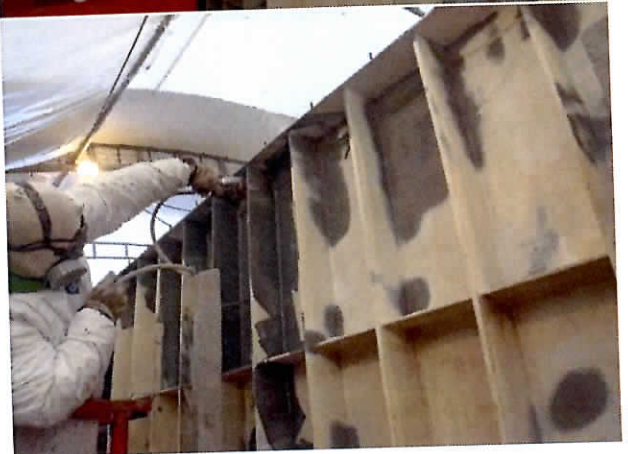
IDR Sheet Sheet 5 of 8	QA Key Personnel Function Structural Inspector	Date Sunday, March 15, 2015
Inspector Doug Brinius		IDR Report # 3/15/2015 DB
Inspector's Notes Continued

TOP SIX: wet film thickness testing, priming repairs of T1, atmospheric conditions

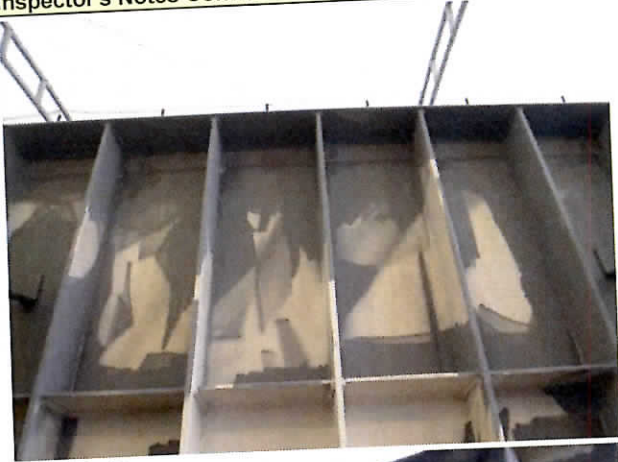
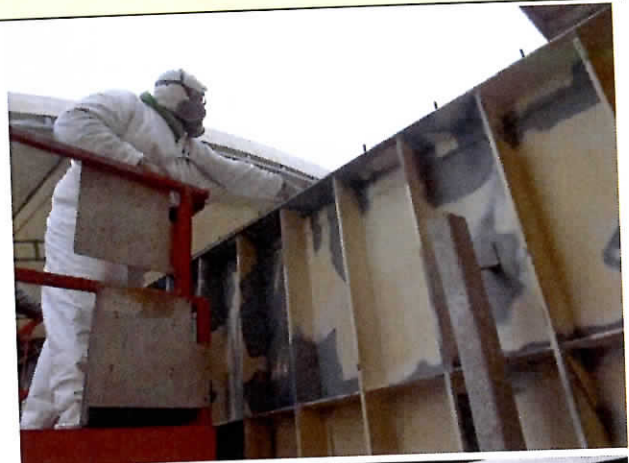
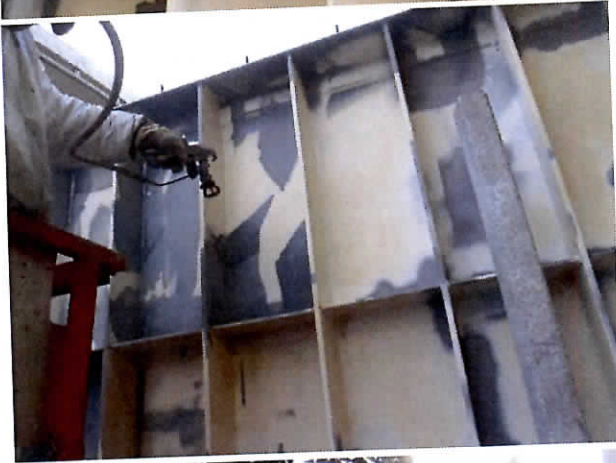
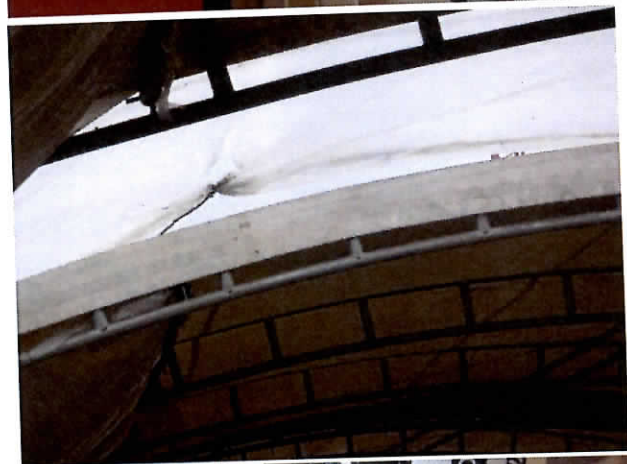
IDR Sheet Sheet 6 of 8	QA Key Personnel Function Structural Inspector	Date Sunday, March 15, 2015
Inspector Doug Brinius		IDR Report # 3/15/2015 DB
Inspector's Notes Continued

TOP SIX: wet film thickness testing, priming repairs of T1, gap noted in tent 2.

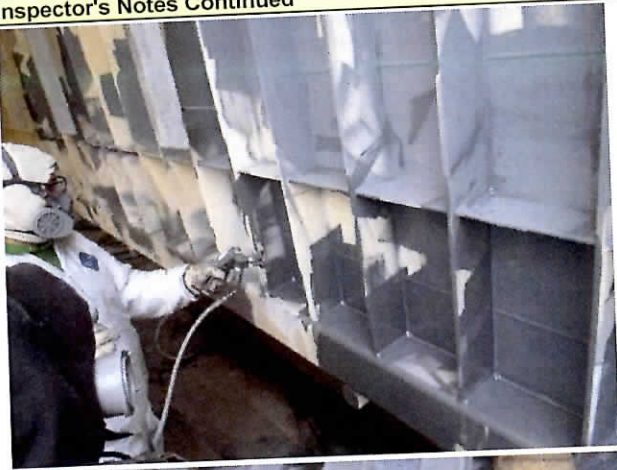
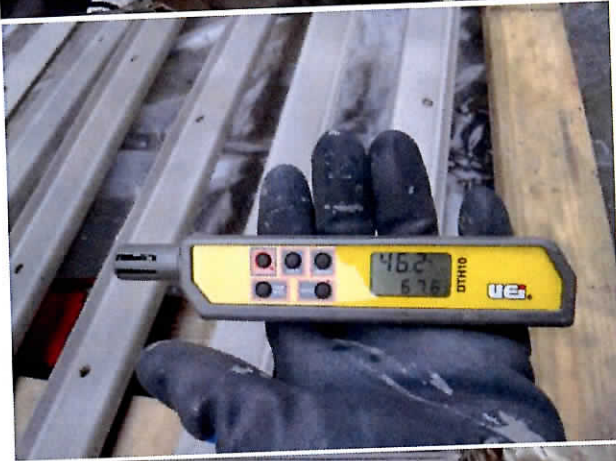
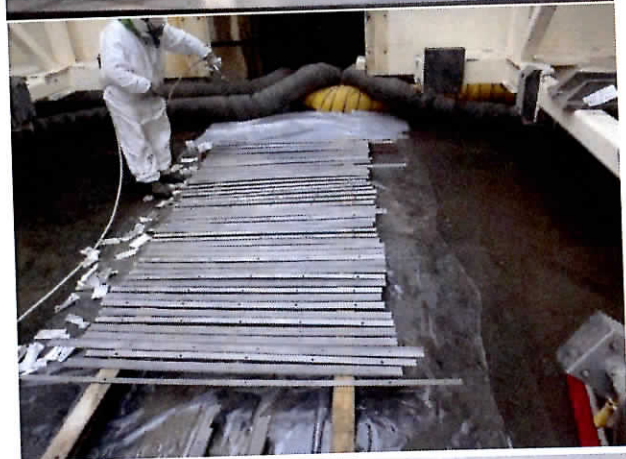
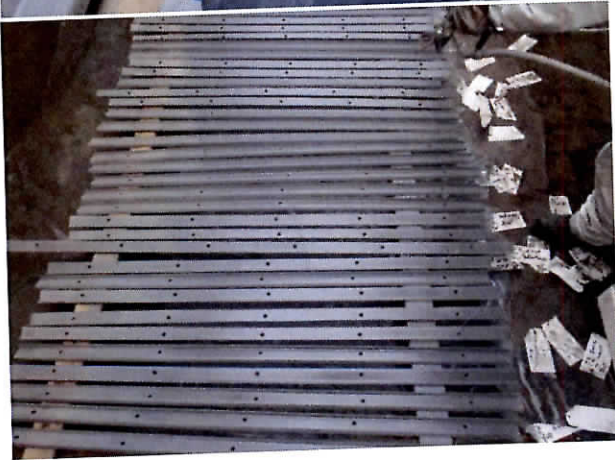
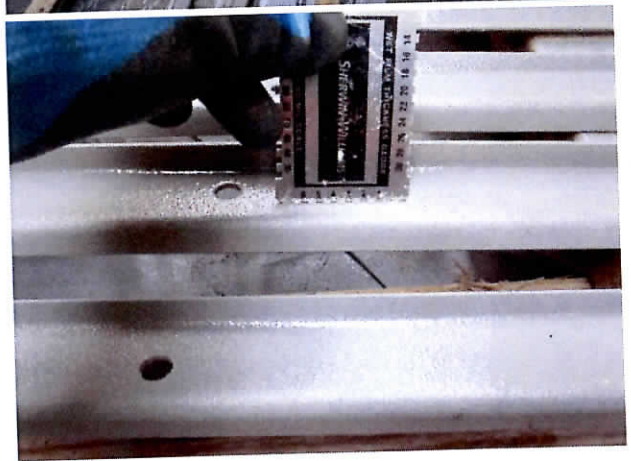
IDR Sheet Sheet 7 of 8	QA Key Personnel Function Structural Inspector	Date Sunday, March 15, 2015
Inspector Doug Brinius		IDR Report # 3/15/2015 DB
Inspector's Notes Continued

TOP SIX: atmospheric conditions for T1, wet film thickness testing, priming SS brackets for T1.

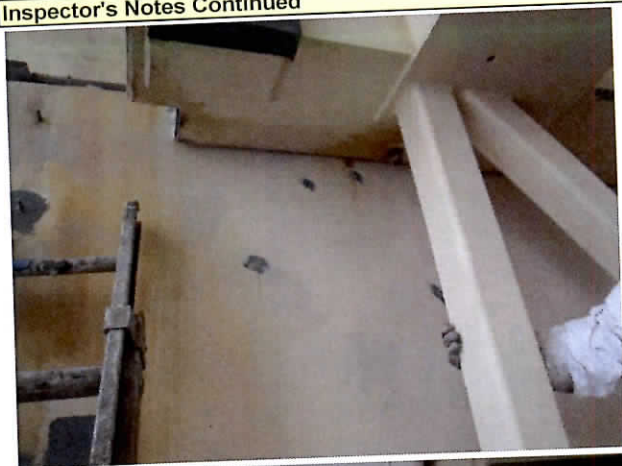
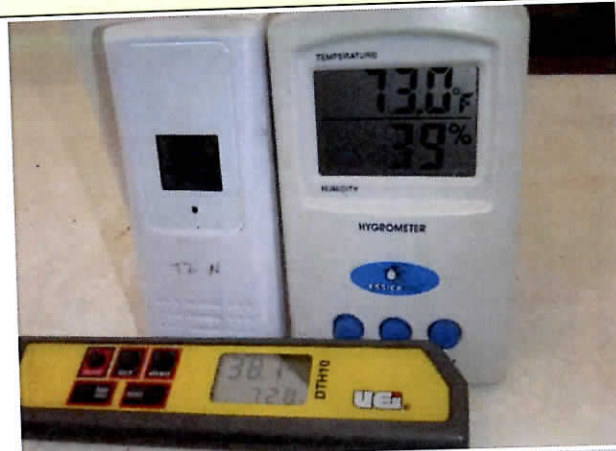
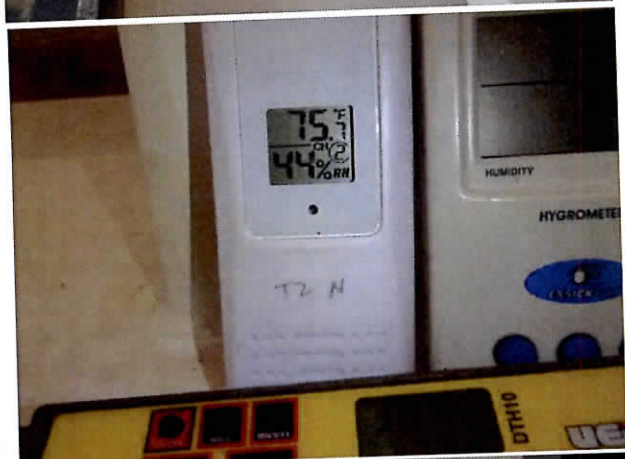
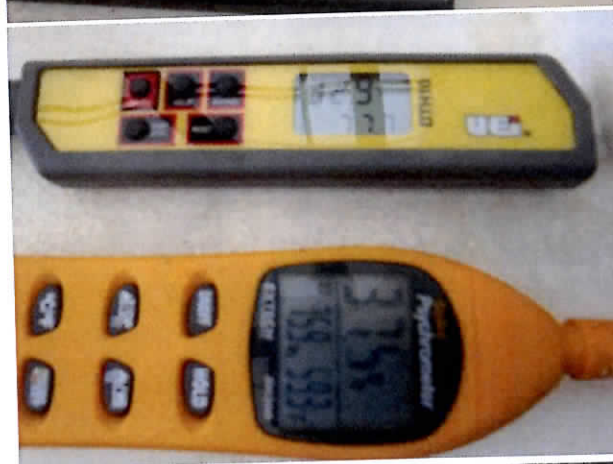
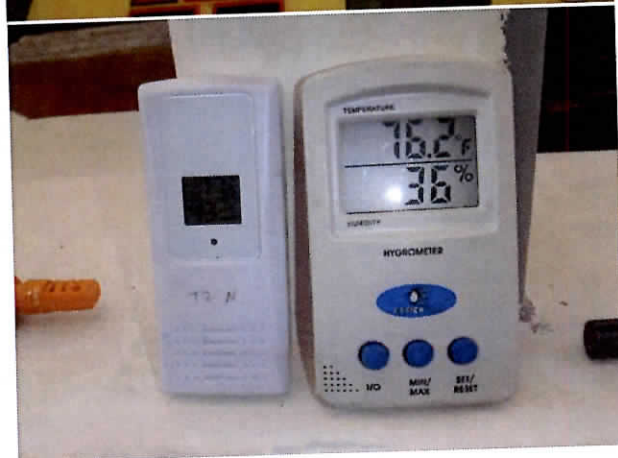
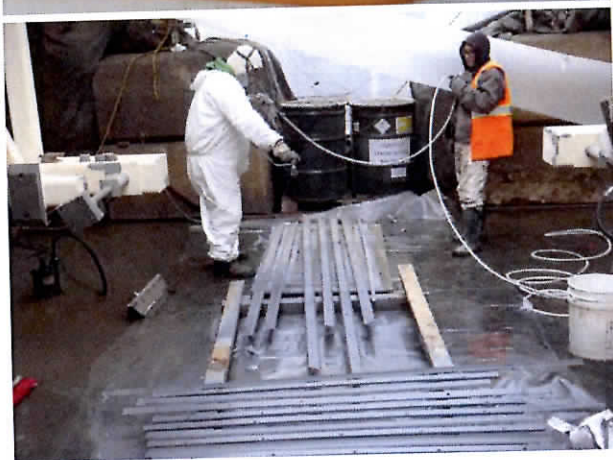
IDR Sheet	QA Key Personnel Function	Date
Sheet 8 of 8	Structural Inspector	Sunday, March 15, 2015
Inspector	IDR Report #	
Doug Brinius	3/15/2015 DB	
Inspector's Notes Continued

TOP SIX: atmospheric conditions for T1, priming SS brackets for T1.

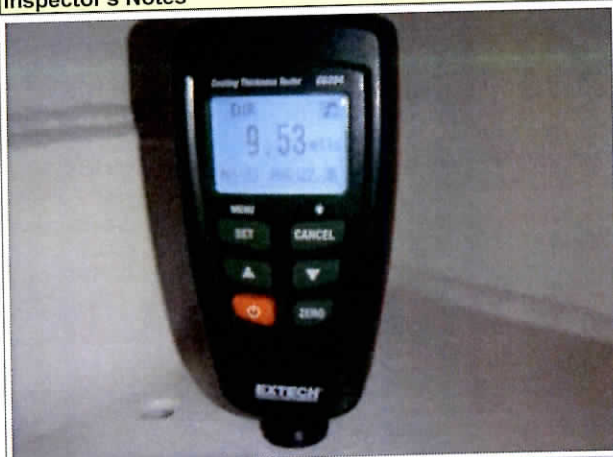
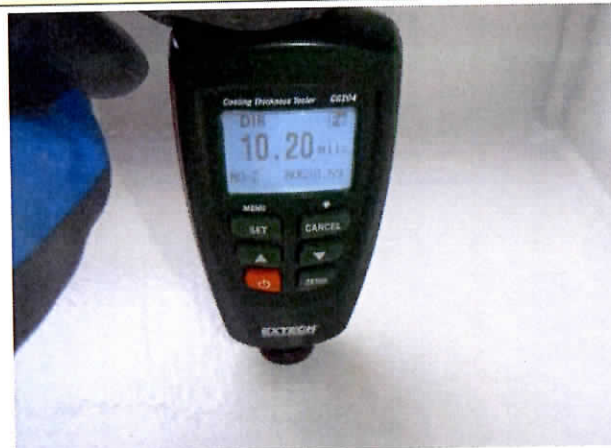
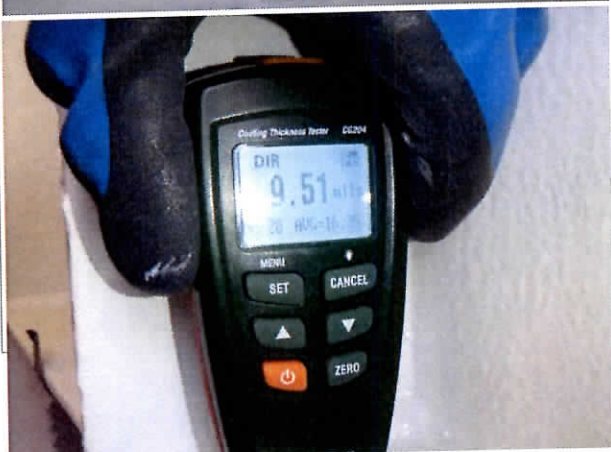
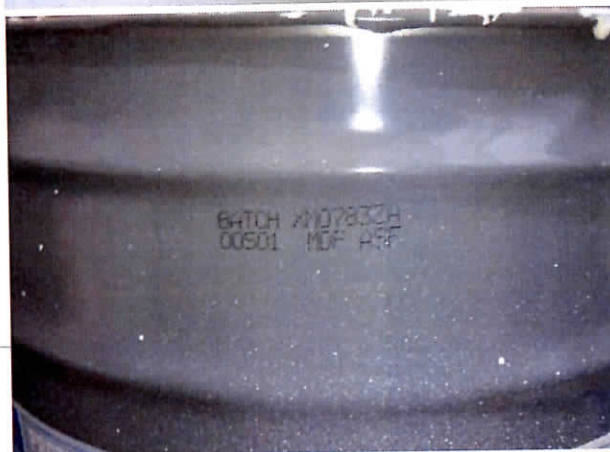
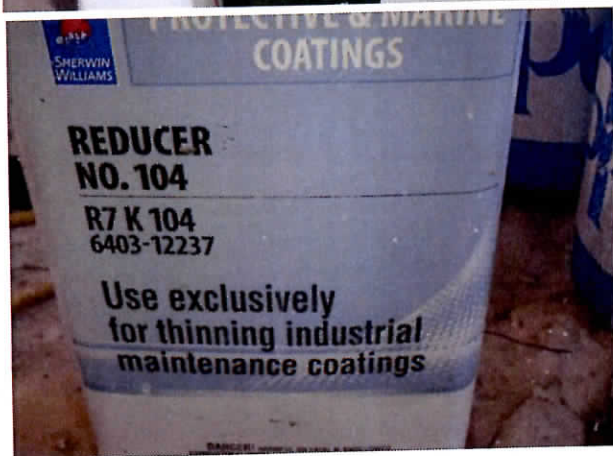
IDR Sheet Sheet 3 of 7	QA Key Personnel Function Structural Inspector	Date Tuesday, March 17, 2015
Inspector Doug Brinius		IDR Report # 3/17/2015 DB
Inspector's Notes

TOP SIX: DFT readings for Dura-Plate T2 and T3 intermediate coats, Dura-plate batches and reducer used

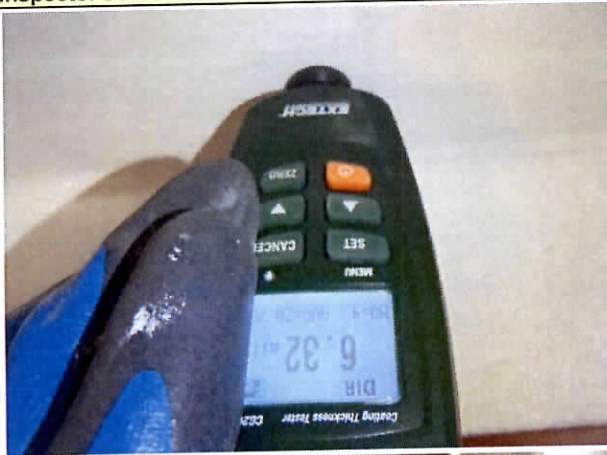
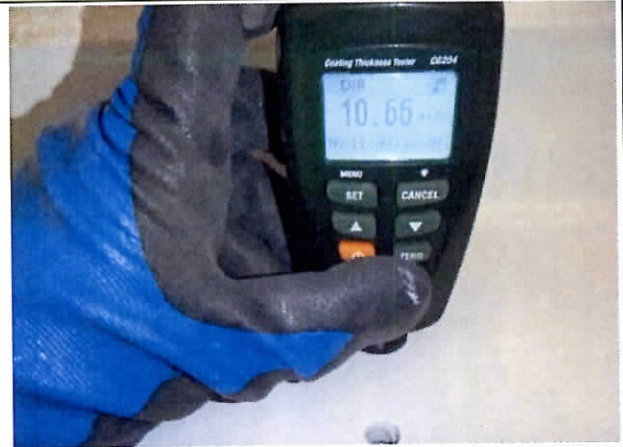
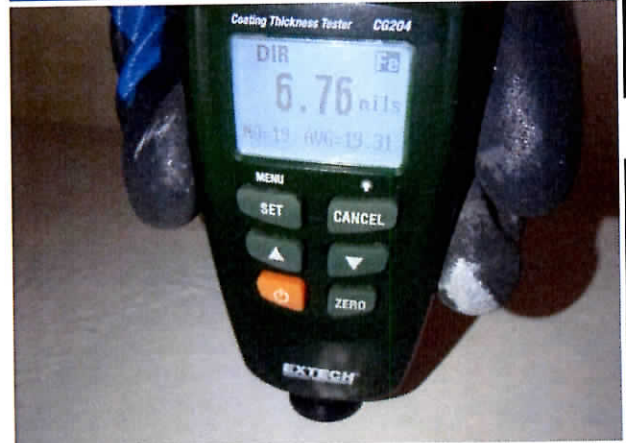
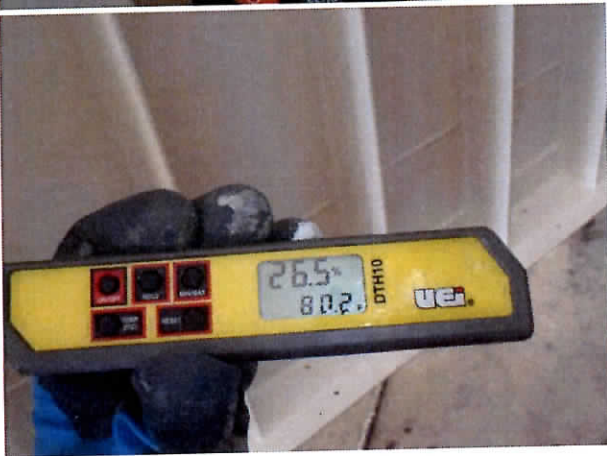
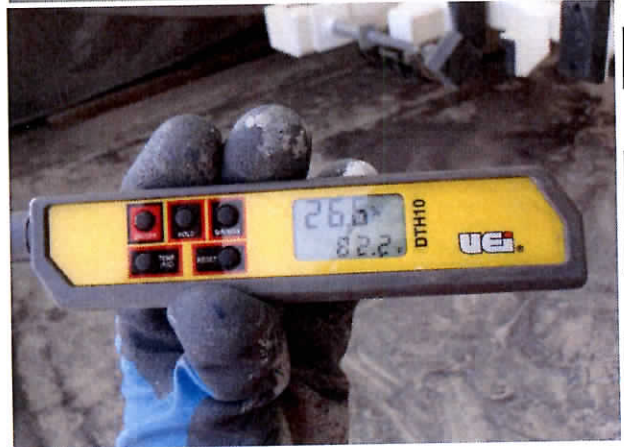
IDR Sheet	QA Key Personnel Function	Date
Sheet 4 of 7	Structural Inspector	Tuesday, March 17, 2015
Inspector Doug Brinius	IDR Report # 3/17/2015 DB	
Inspector's Notes

TOP FOUR: DFT readings for Dura-Plate T2 and T3 intermediate coat  
BOTTOM TWO: Conditions for top coat for Dura-Plate T2 and T3 top coat

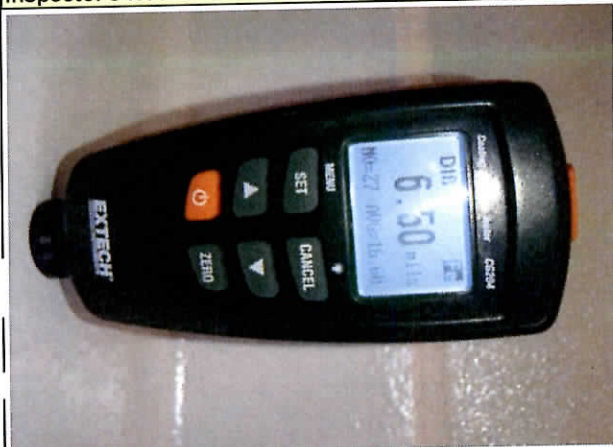
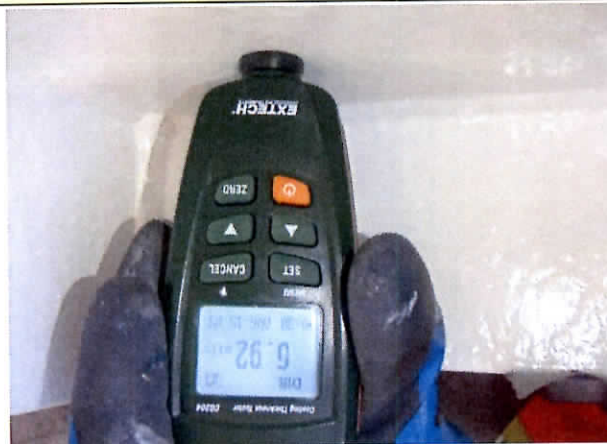
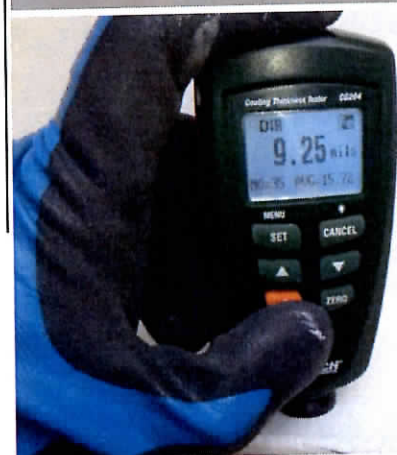
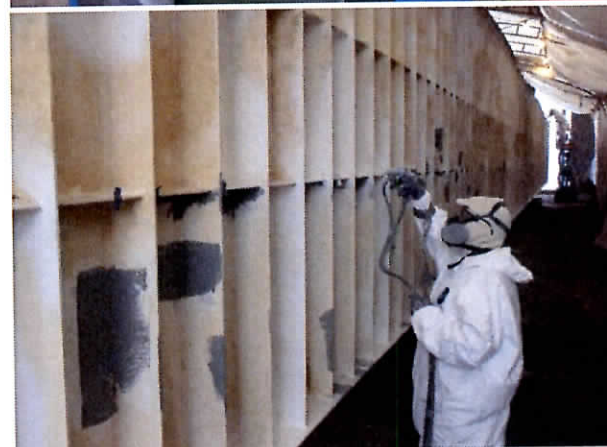
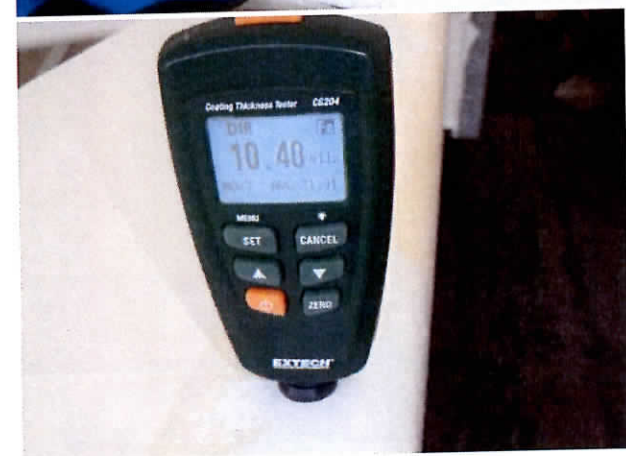
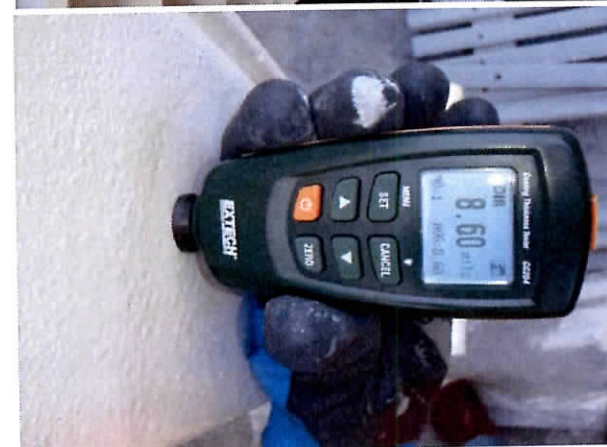
IDR Sheet	QA Key Personnel Function	Date
Sheet 5 of 7	Structural Inspector	Tuesday, March 17, 2015
Inspector Doug Brinius	IDR Report # 3/17/2015 DB	
Inspector's Notes Continued

TOP SIX: DFT readings for Dura-Plate T2 and T3 intermediate coat and top coat of Dura-Plate

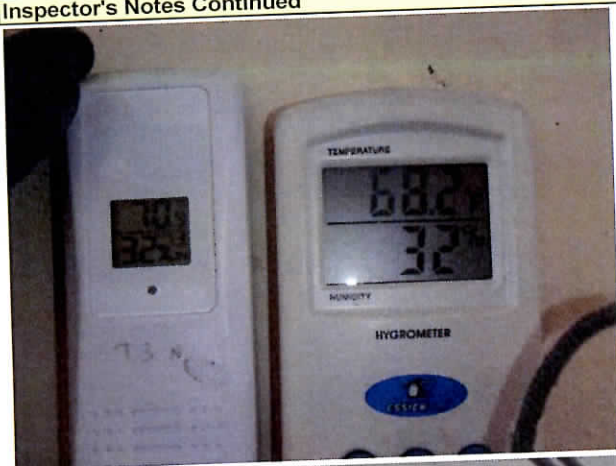
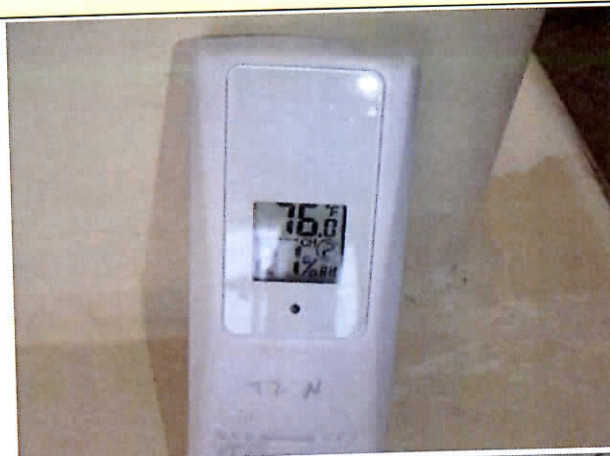
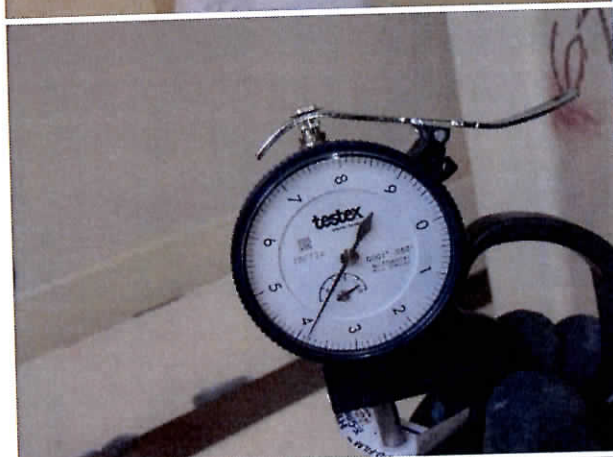
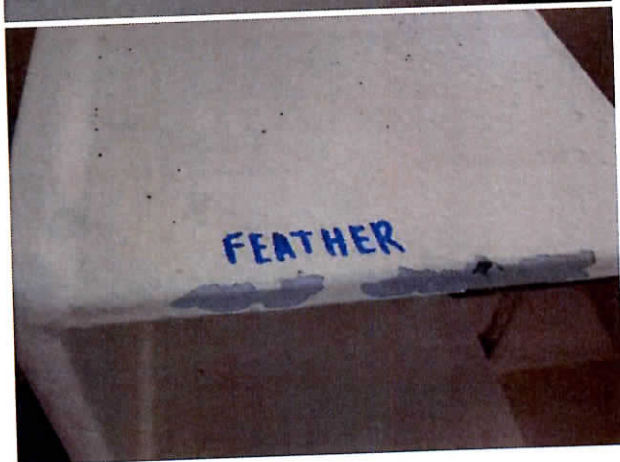
TOP SIX: Atmospheric conditions for T2 and T3 top coats, anchor profile, areas of concern of T2 and T3
